How can we reduce the energy demands of 1 Brookside, a Grade II listed, uninsulated University building?

1 Brookside - The building fabric and services

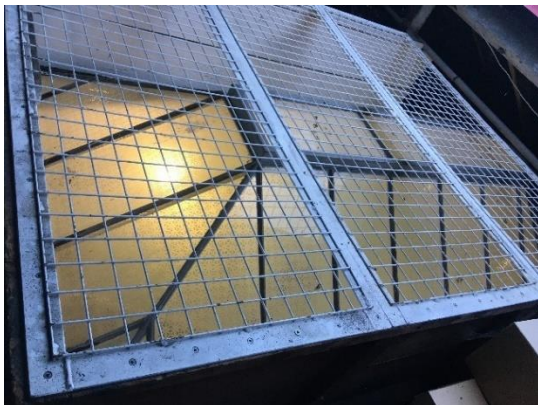
Over the stairwell there is a single-glazed roof lantern which sits within the loft space.

Decorative roof lantern to stairwell viewed from attic space

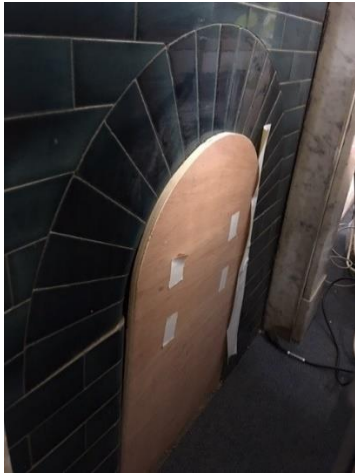
Fireplaces are generally boarded up to varying degrees. It is believed that the chimneys are open – with no chimney cushions or chimney caps (wind can be heard blowing down the chimney from fireplaces).

Fireplace in Admin office

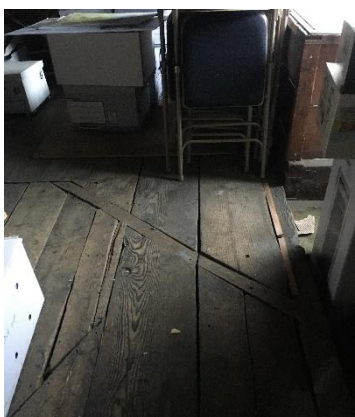
Uninsulated floor in attic

An area of 30m² in the centre of the loft has no insulation. This area is above offices and the central hallway and stairwell circulation space.

The installation of insulation across the entire attic space, to the recommended depth of 300-400mm would make a substantial contribution to containing energy within the building. Currently approximately 130m² of the roof space is insulated with just 100mm of insulation, leaving 30m² with no insulation whatsoever. The space is used for storage so additional batons and boards would be required to raise the level of the floor to provide sufficient depth for the insulation.

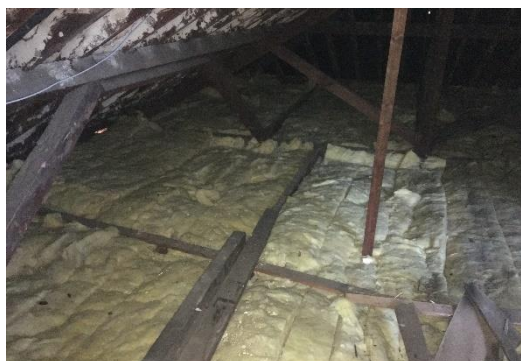
The only evidence of insulation in the building is to be found in the loft space. Approximately 100mm deep fibreglass insulation has been laid between floor joists across approximately 130m² in the loft. Most buildings have this low-cost measure in place already - it is essentially a minimum provision and falls far short of the 300-400mm depth recommended by Cambridge City Council, “We recommend an extra 200-300mm, which should be laid at a right angle to the layer of insulation below, to limit gaps forming.” [*Retrofitting your Home – September 2022 – Cambridge City Council*]

100mm insulation in the attic

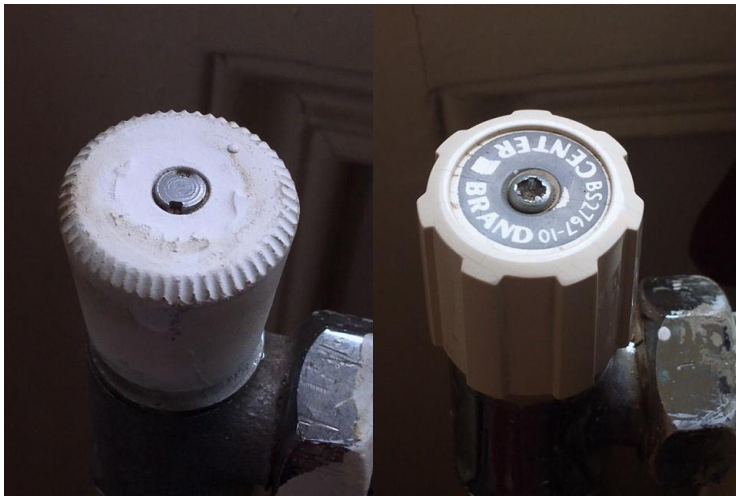
The Estates Manager attempted to resolve the issue by adjusting the heating system's flow rate, but it was explained that the compensation controlled heating system made it impossible to achieve a

long-term satisfactory setting and any adjustments made that day would need to be undone to ensure the building heated sufficiently on colder days.

Examples of seized radiator flow and return valves

Issues with radiator valves were identified in several rooms in the building. The common issue was that the radiator controls had seized, making any adjustment either extremely difficult or impossible. “Just to confirm that we are unable to turn off/adjust the two radiators in our office. [the Estates Team] have looked at them and were unable to adjust them.” Finance office staff member. Replacement with thermostatic valves would ensure that comfortable temperatures were maintained without the need for intervention from staff members on milder days.

On warmer days, where radiators could be adjusted, the corresponding reduction in temperature of the radiator units was slow – replacement of the radiator units themselves should possibly be considered.

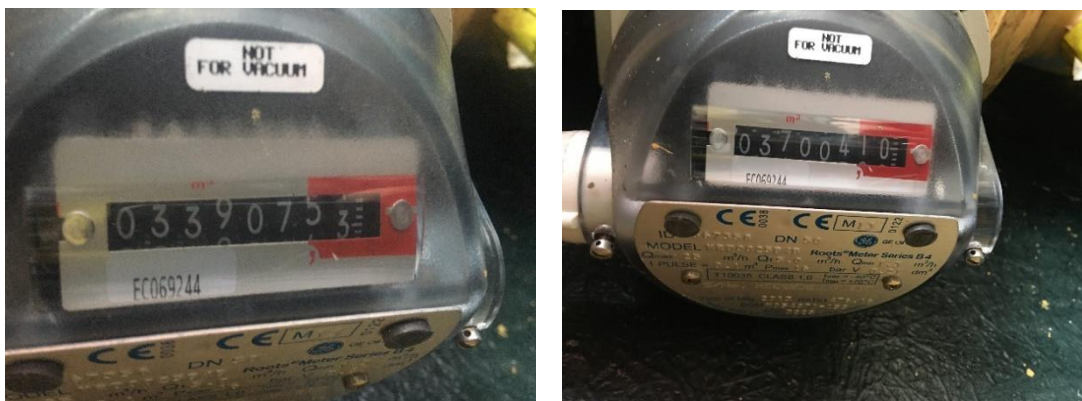
The first (taken on 13 December 2022) and last (taken on 20 March 2023) gas readings taken for the project

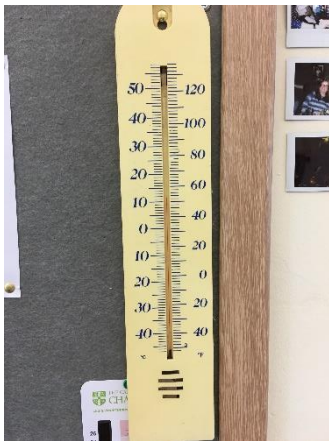
The lowest internal temperature recorded in the building was on 16 December. The internal temperature was 11°C – this was recorded on a thermometer placed by the Learning Team (as the Cambridge *green* Challenge thermometers could not record below 16°C); the external temperature that day ranged between 0.4°C max and -8.4°C min. The image to the left shows this temperature reading. The staff member working in the Learning Office on this day noted: "The day it was absolutely freezing in here and I went home: you just can't even think in temperatures like that, sat down. It's not reasonable to expect staff to work in a coat and with another coat over their knees – especially when they know that at home they have a lovely warm house! The university had not provided me with a laptop so I couldn't work from

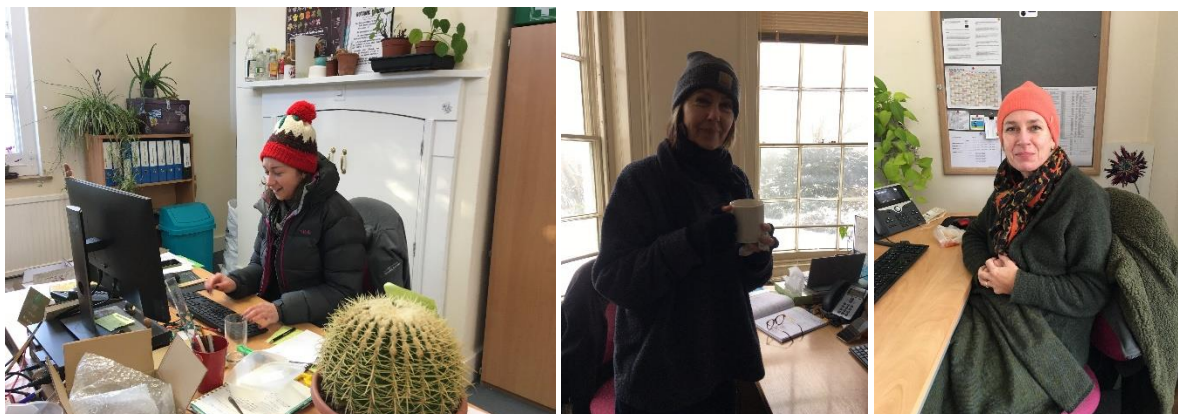
(<https://www.hse.gov.uk/temperature/employer/the-law.htm>) is 16°C, or 13 degrees "if much of the work involves rigorous physical effort." As this is an administrative office, the 16°C limit should apply. To be able to continue working in these conditions staff had to wear outdoor clothes, coats, hats, scarves etc.. in order not to freeze.

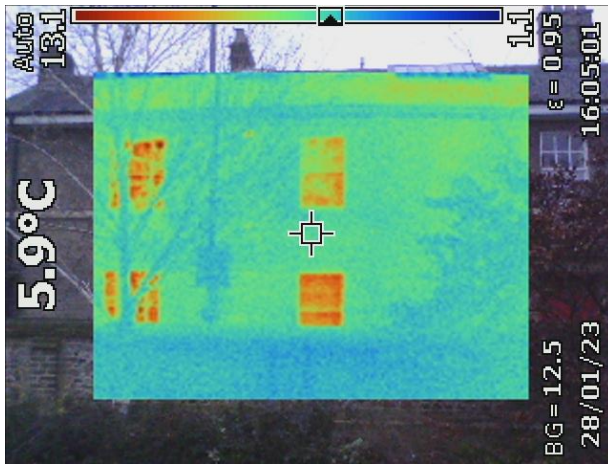
Again, in this image of the Bateman Street side of the building, you can see heat leaking mostly through windows but also through walls and roof

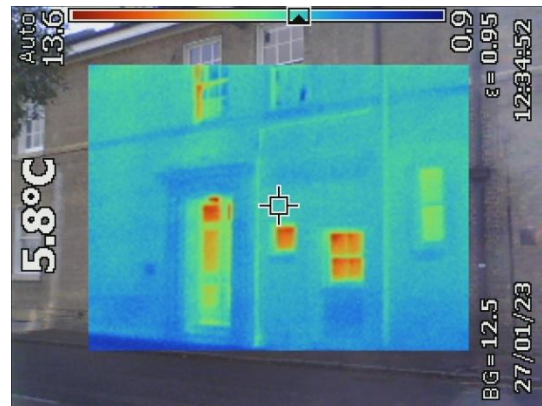
Main entrance from exterior, with heat loss seen through single glazing and wood panelling of door and windows

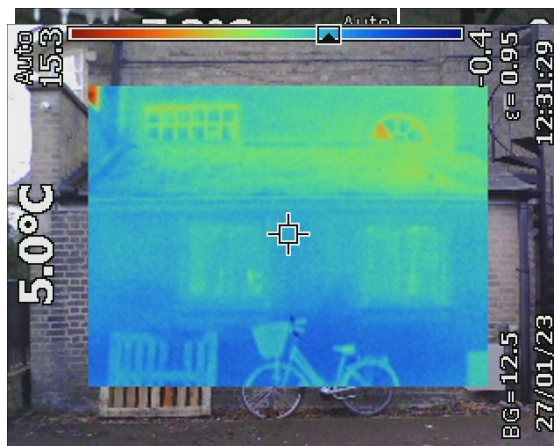
This image shows heat loss through the roof and around the bay structure around the ground floor meeting room. Here heat can be seen leaking at the junctions of the building's wall with the

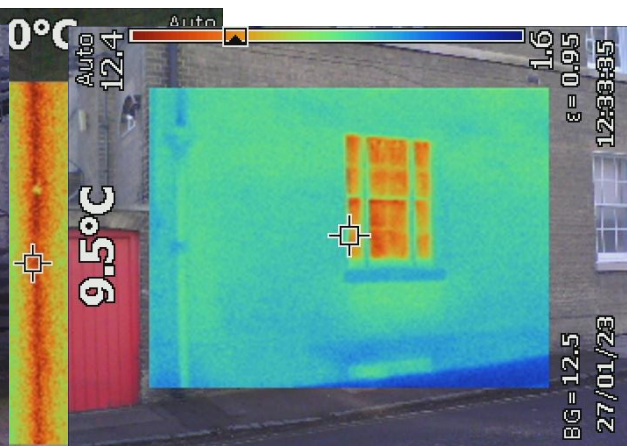
This image shows heat escaping from window but also a warm spot under the window where a draught is present.

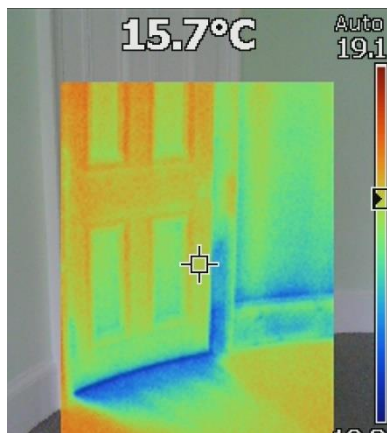
A cold draught showing under internal (MCB board) cupboard in stairwell
